FULL-SCALE ROOM BURN PATTERNS STUDY

ABSTRACT

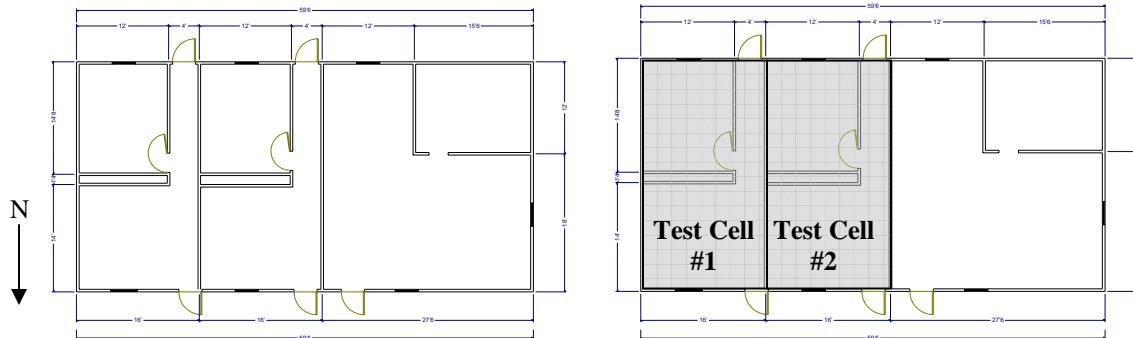
Figure 1 (left) layout of EKU test burn building; Figure 2 (right) location of test cells

The test facility used for all these recent experiment sets was the Eastern Kentucky University, Fire and Safety Engineering and Technology Program's test burn building, located on the EKU campus in Richmond, Kentucky. This structure is a specially constructed, single story building with overall dimensions of approximately 18.9 m x 9.75 m (62 feet x 32 feet). It incorporates six interconnected burn rooms and two hallways all with 8" reinforced concrete walls and roof. Individual test cells can be configured into various shapes and sizes by isolating individual spaces with gypsum wallboard partitions (see Figure 1).

The test cells for this research project encompassed the east half of the facility configured into two identical 4.88 m by 9.75m (16' by 32') cells (Figure 2). The cells were constructed of 8" poured, reinforced concrete walls, which were lined with 2x6 joists and gypsum wallboard (See Figure 2). All dimensions are approximated.

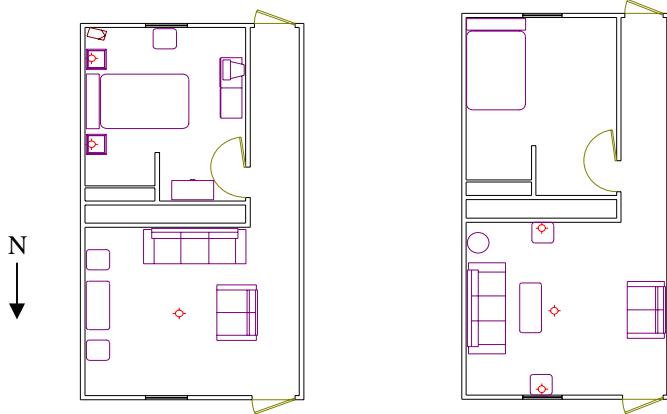
**Figure 3 (left) Furniture Layout for Experiment Set "A" & "C";
Figure 4 (right) furniture layout for Experiment Set "B"**

Experiment sets “A” and “C”: Experiment sets “A” and “C” (conducted in March 2005 and March 2006) were roughly identical in the layout and types of furniture (Figure 3). The rooms were furnished as typical residential bedrooms and living rooms. The contents of each bedroom included a bed, chest, two lamps, end tables, two nightstands, television (not included in experiment set “C”), clothing and a dresser with an attached mirror. The bedrooms had wall-to-wall carpeting on the floor. The contents of each living room included a couch, loveseat, coffee table, two end tables, and television. The living room as well as the hallway had wall-to-wall carpeting on the floor.

Experiment set “B”: Experiment set “B” (conducted in November 2005) was furnished as a residential living room. The living rooms consisted of a couch, loveseat, three end tables, two lamps and a coffee table. The living room as well as the hallway had wall-to-wall carpeting on the floor. The bedroom consisted of a single mattress with bedding material (Figure 4).

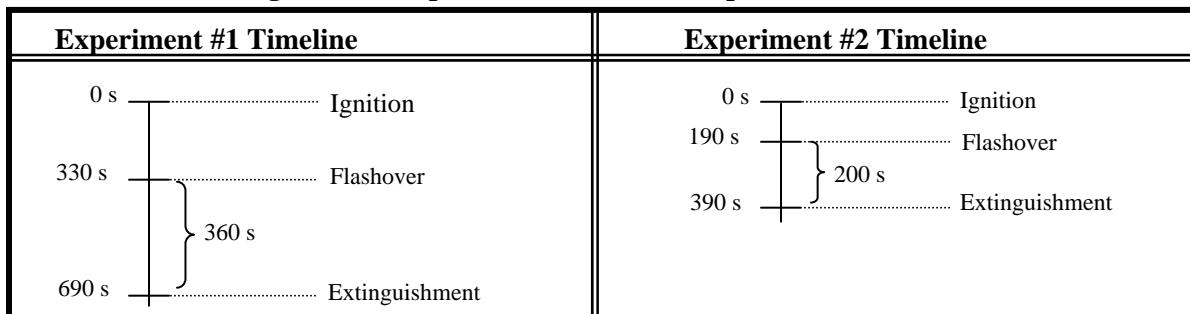
Figure 5– Comparison of Timelines Experiment Set “A”

The temperatures measured by the thermocouple tree located in the bedroom of each experiment are shown in Figures 6 and 7. In cell #1 (experiment #1), the technical indicator of 600°C (1112°F) in the upper layer for flashover was achieved at approximately 330s (seconds). The duration of the post-flashover/fully involved stage of the fire, the time between flashover and suppression, for experiment #1 was 360 s. In cell #2 (experiment #2), the technical indicator for flashover of 600°C (1112°F) in the upper layer was achieved at approximately 190s. The duration of the post-flashover/fully involved stage of the fire for experiment #2 was 200s. Figure 5 illustrates a timeline for each experiment.

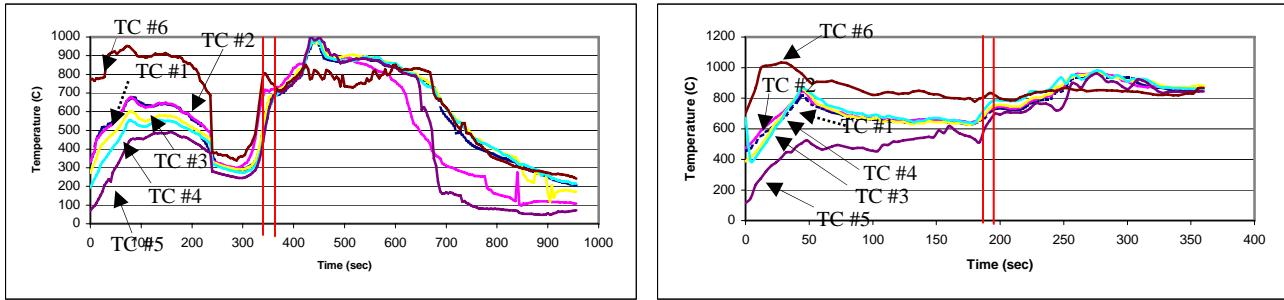
Figures 6 & 7 – Experiment Set “A” Thermocouple Data: (left)-Cell #1 (exp. 1); (right)-Cell #2 (exp. 2)

The ventilation conditions for the experiments were expected to differ slightly due to the different locations of the rooms within the test burn building. The differences in ventilation are also suggested by the differences in the temperature growth profiles between experiments #1 and #2. In experiment #1, prior flashover, at 230s a substantial uniform decrease in temperature for all thermocouples was recorded. However, in experiment #2, only a minor decrease in temperature was recorded for all thermocouples just prior to flashover.

A possible reason for the dramatic decrease in temperatures seen in experiment #1 and the resulting differences between the two temperature growth profiles is that the fire in experiment #1 became ventilation-controlled early on during the growth of the fire. This resulted in a decrease in temperature and a subsequent increase in time to flashover. Once sufficient oxygen concentrations returned, the fire quickly grew to transition through flashover conditions and into full-room involvement.

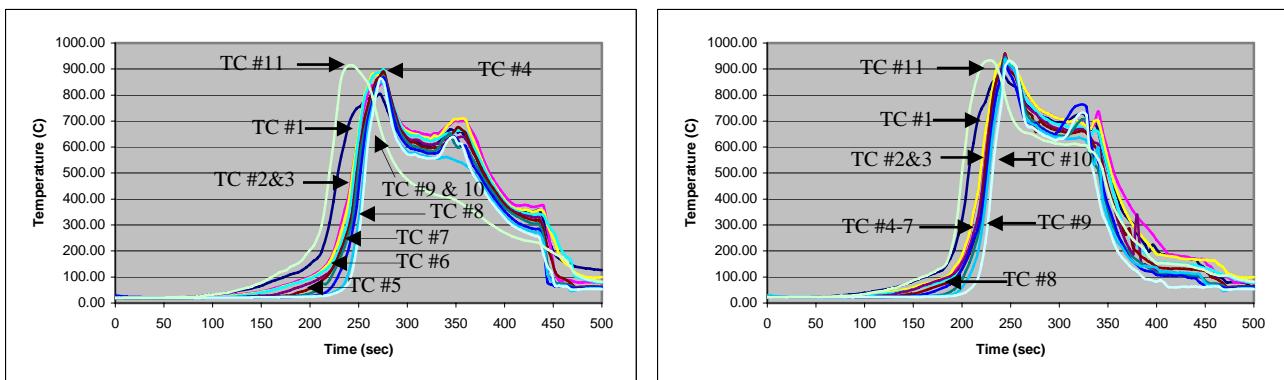
Figures 9 & 10 – Experiment Set “B” Thermocouple Data: (left)-Cell #1 (exp. 3); (right)-Cell #2 (exp. 4)

The temperatures measured by the thermocouple tree located in the living room of each experiment are shown in Figures 9 and 10. In cell #1 (experiment #3) the technical indicator for flashover of 600°C (1112°F) in the upper layer was achieved at approximately 236s (seconds). Also, in experiment #3, the duration of the post-flashover/fully involved stage of the fire was 124s. In cell #2 (experiment #4) the technical indicator for flashover of 600°C (1112°F) in the upper layer was achieved at approximately 212s. Also, in experiment #4, the duration of the post-flashover/fully involved stage of the fire was 120s. The temperature growth profiles from experiments #3 and #4 are almost identical. Figure 8 illustrates a timeline for each experiment.

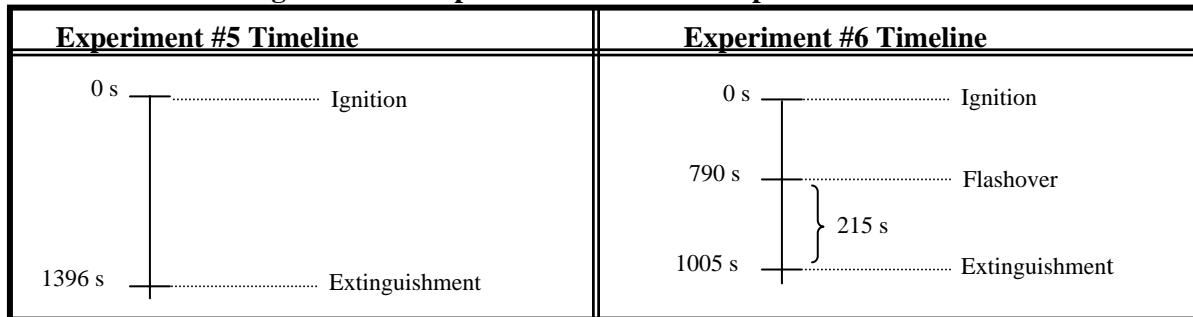
Figure 11 – Comparison of Timelines Experiment Set “C”

room involvement did not occur. This was evident from the radiometer readings (figure 14), as well as the post-fire inspection of the furnishings (Figures 34, 38, 42 and 46). In cell #2 (experiment #6), the technical indicators for flashover of 600°C (1112°F) in the upper layer and radiant flux of 20kW/m² at the floor were achieved at 790s (Figure 15). The duration of the post-flashover/fully involved stage of the fire for experiment #6 was 215s. Figure 11 illustrates a timeline for each experiment.

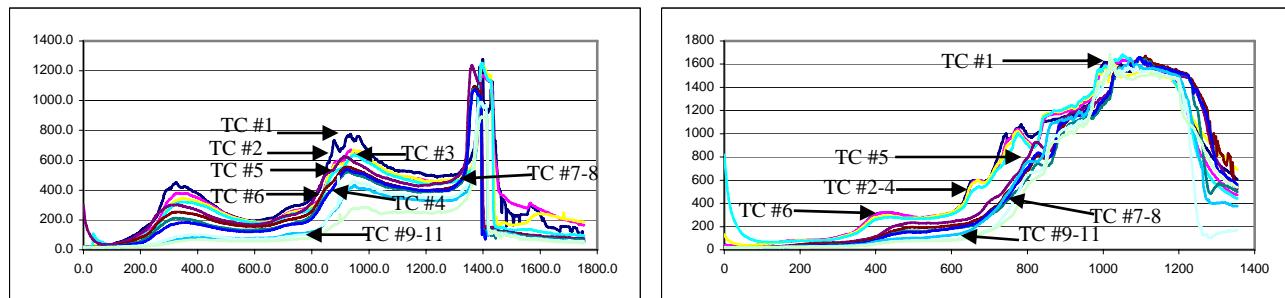
Figures 12 & 13 – Experiment Set “C” Thermocouple Data: (left)-Cell #1 (exp. 5); (right)-Cell #2 (exp. 6)

The test in cell #1 (experiment #5) was stopped early due to hazardous weather conditions creating an unsafe work environment. The temperatures measured by the thermocouple tree located in the bedroom of each experiment are shown in Figures 12 and 13. In experiment #5, the technical indicator for flashover of 600°C (1112°F) in the upper layer was achieved at approximately 1396s (seconds). However, the full transition of flashover into full-

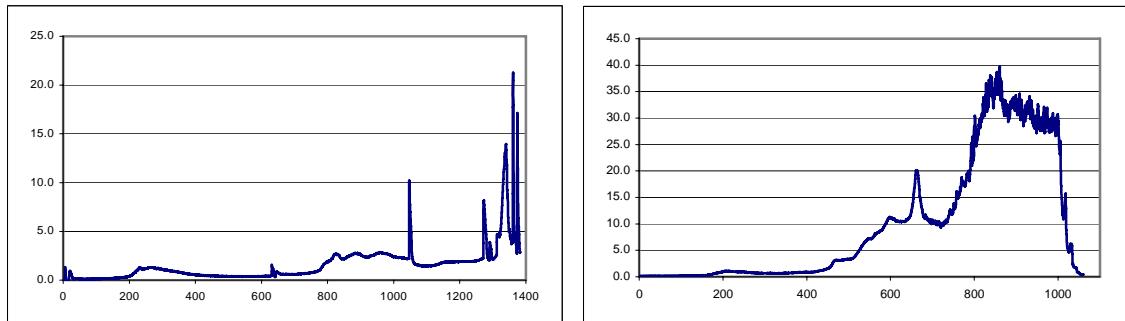
Figures 14 & 15 – Experiment Set “C” – Cell #1 (left) & Cell #2 (right) Radiometer Data

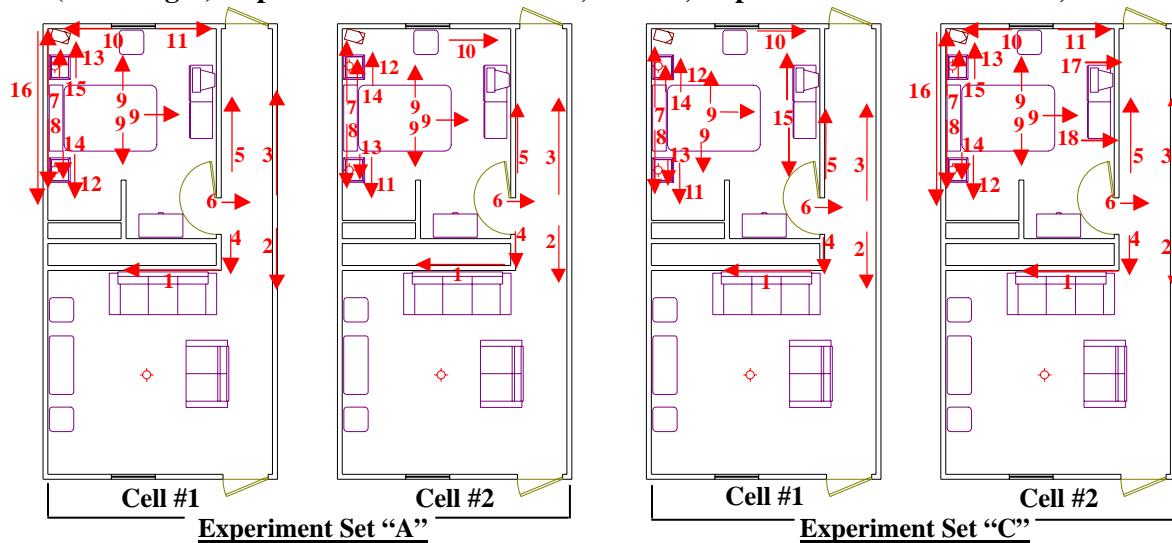
Figures 16-19 – Comparison of Heat and Flame Vector Diagrams

(left to right) Experiment Set “A”: Cell #1; Cell #2; Experiment Set “C”: Cell #1; Cell #2

Heat and Flame Vector Analysis: Each experiment was individually analyzed for all identifiable patterns. A heat and flame vector (arrow) was drawn on the respective diagram for each pattern to represent the direction of movement (fire spread). Experiment sets “A” and “C” were identical in furniture layout, and therefore, have been placed side-by-side for comparison purposes of their respective heat and flame vector diagrams (Figures 16-19). Experiment set “B” heat and flame vector diagrams are shown in Figures 20 and 21.

The Heat and Flame Vector diagrams for experiment sets “A” and “C” (experiments 1, 2, 5 and 6) demonstrate consistency. In fact, the first nine vectors for all four experiments show remarkable resemblance to each other and form the basis for the reliability of utilizing patterns and heat and flame vector diagrams for the accurate identification of an area of origin. Experiment set “B” (experiments 3 and 4) demonstrates even stronger consistency in vector analysis. Every pattern from experiment #3 was reproduced in experiment #4.

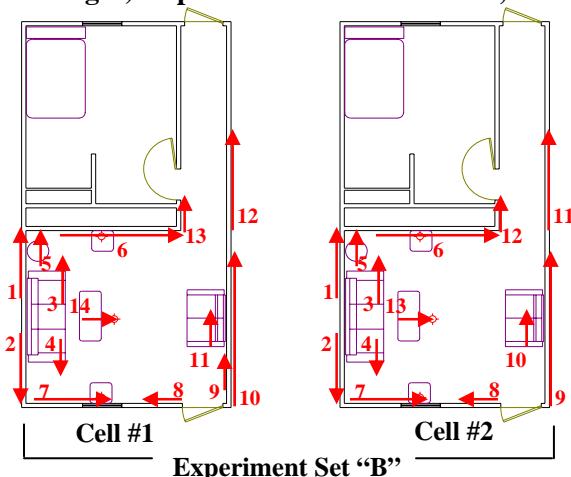
Figures 20 & 21 – Comparison of Heat and Flame Vector Diagrams

(left to right) Experiment Set “B”: Cell #1; Cell #2

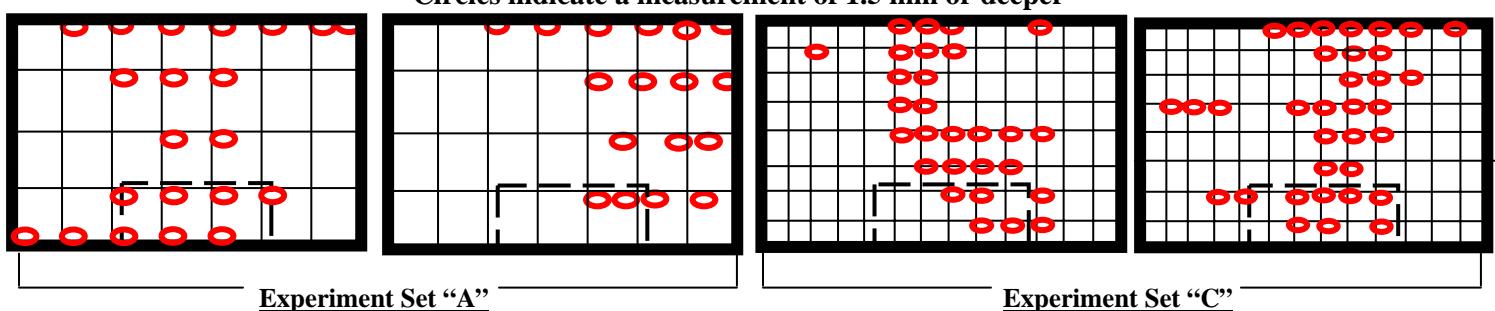
Figures 22-25 – Comparison of Depth of Calcination Elevation (East Wall) Diagrams
 (left to right) Experiment Set “A”: Cell #1; Cell #2; Experiment Set “C”: Cell #1; Cell #2
 Circles indicate a measurement of 1.5 mm or deeper

Depth of Calcination: Depth of calcination measurements were taken and recorded utilizing a depth gauge on a two-foot by two-foot grid for experiment set “A” and a one-foot by one-foot grid for experiment sets “B” and “C”. These depths of calcination readings have been transferred onto depth of calcination diagrams for additional pattern comparisons (Figures 22 and 27). Experiment sets “A” and “C” are illustrated by an elevation diagram of the east bedroom wall with the outline of the bed illustrated by a dashed line (Figures 22-25). A circle indicates a measurement of 1.5 mm or deeper, thus displaying a pattern of similar total heating. Experiment set “B” is demonstrated by an elevation diagram of the east wall with the outline of the couch illustrated by a dashed line (Figures 26 & 27). A circle indicates a measurement of 0.7 mm or deeper, thus displaying a pattern of similar total heating.

A review of the depth of calcination diagrams with the post-fire photographs illustrates similarities between the visible patterns that remain and the measured intensity patterns in and on the calcined wallboard. Though there are slight differences in the resemblance of the diagrams from different tests, a general consistency is demonstrated between all of them.

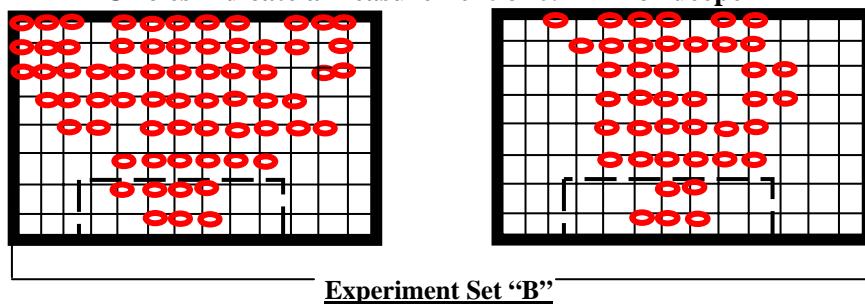
Figures 26 & 27 – Comparison of Depth of Calcination Elevation (East Wall) Diagrams
 (left to right) Experiment Set “B”: Cell #1; Cell #2
 Circles indicate a measurement of 0.7 mm or deeper

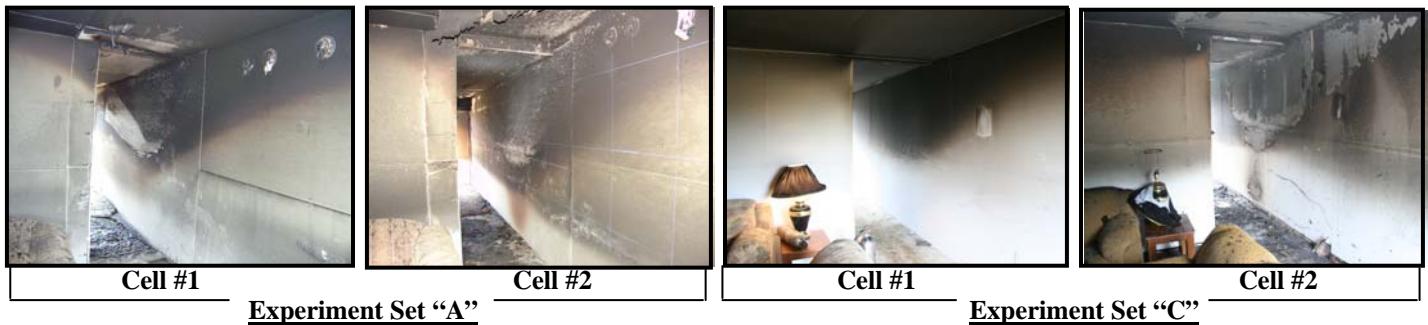
Similar truncated cone patterns (i.e. boundary patterns) were witnessed on the walls in all four experiments. The patterns remaining on the hallway walls demonstrate consistency. All four experiments produced a “U-shaped” pattern opposite the doorway on the hallway wall. The only difference that existed was the pattern in experiments #2 and #6 had a lower vertex than experiments #1 and #5 (Figures 28-31).

Figure 28-31 – Hallway (left to right) Exp. Set “A”: Cell #1, Cell #2; Exp. Set “C”: Cell #1, Cell #2

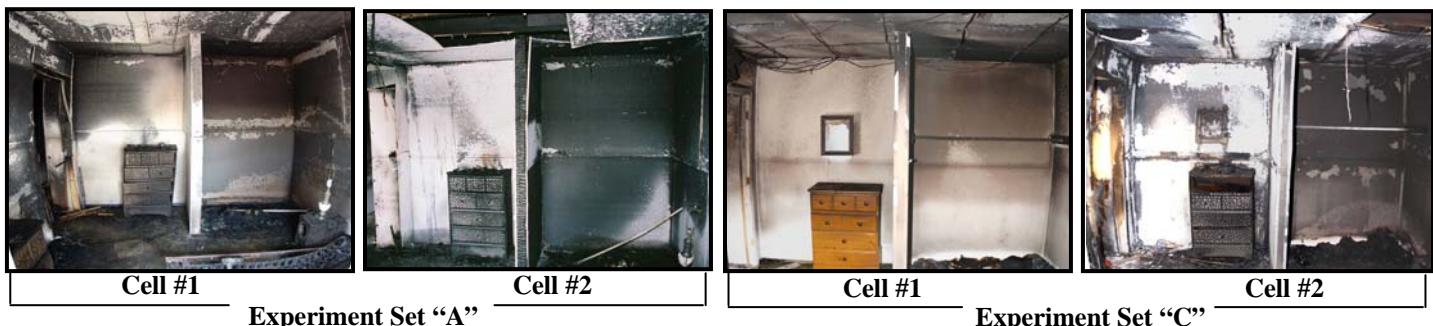
Along the north wall, a similar area of clean burn located on the west side above the chest was witnessed for the three experiments that progressed to full-room involvement (Figures 32, 33 and 35). Also, similar lines of demarcation are witnessed for all four experiments (Figures 32-35).

Figure 32-35 – North Wall (left to right) Exp. Set “A”: Cell #1, Cell #2; Exp. Set “C”: Cell #1, Cell #2

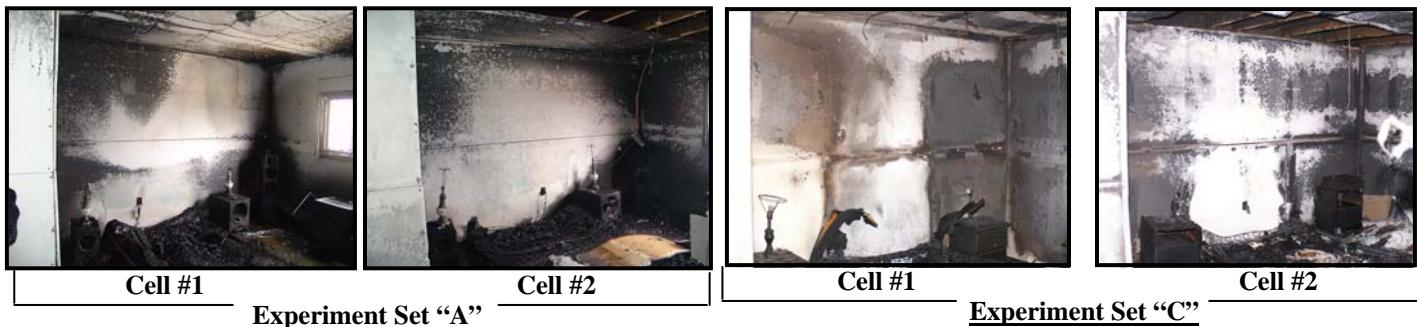
A consistency of the plume pattern on the east wall directly above the bed was witnessed for all four experiments. Additionally, a similar elongation of the plume pattern toward the south wall, where the window was located, was witnessed in all four experiments (Figures 36-39).

Figure 36-39 – East Wall (left to right) Exp. Set “A”: Cell #1, Cell #2; Exp. Set “C”: Cell #1, Cell #2

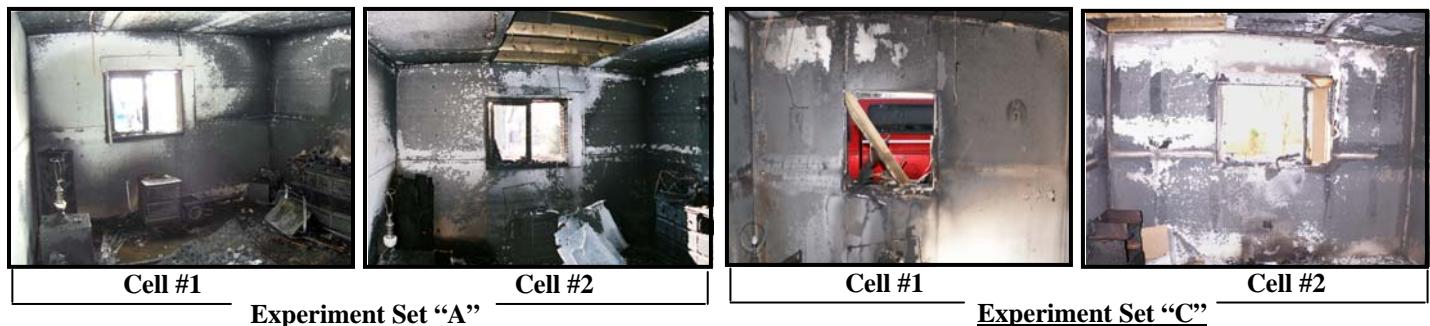
The plume pattern on the east wall also extended onto the south wall with an area of greater damage (clean burn) for all four experiments witnessed near the ceiling of each wall and the window. Additionally, a “U-Shaped” pattern was witnessed along the south wall for all four experiments that corresponded with the truncated cone of the plume originating from the bed (Figures 40-43).

Figure 40-43 – South Wall (left to right) Exp. Set “A”: Cell #1, Cell #2; Exp. Set “C”: Cell #1, Cell #2

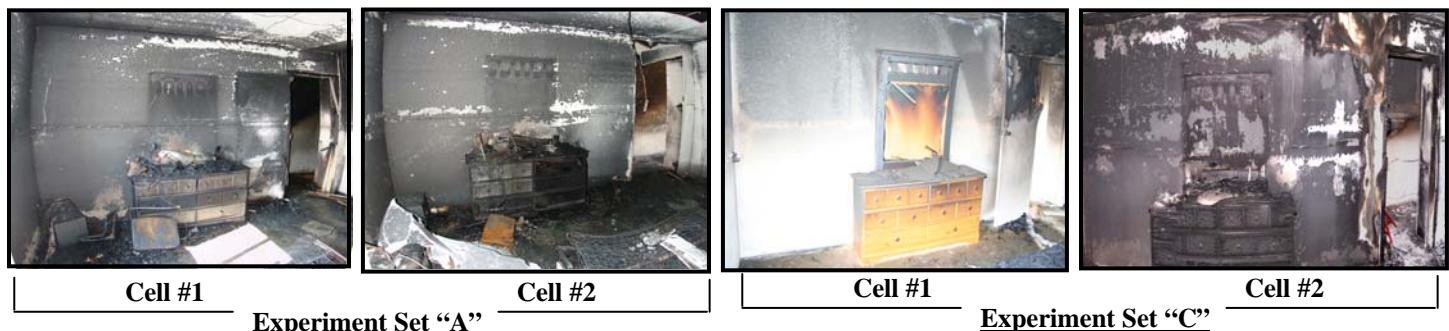
The patterns remaining on the west wall of the bedroom in all four experiments show good consistency (Figures 44-47). For example, protected area patterns remain on the west wall in the pre-fire location of the door and mirror for all four experiments.

Figure 44-47 – West Wall (left to right) Exp. Set “A”: Cell #1, Cell #2; Exp. Set “C”: Cell #1, Cell #2

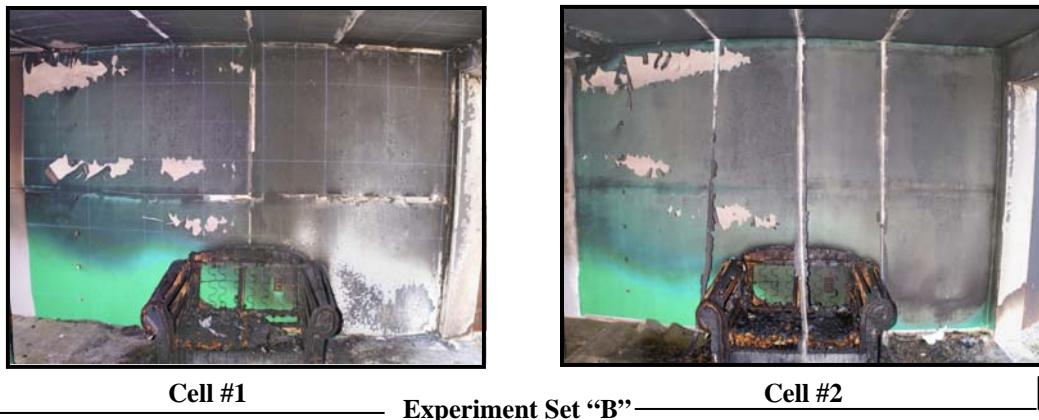
Experiment set “B” (experiments #3 and #4) demonstrated remarkable similarity of the fire patterns. The loss of material patterns for the couch, loveseat, and end tables were almost identical (Figures 48-55). The ventilation patterns near the doorway were similar (Figures 48 and 49). The demarcation lines on the west wall corresponding to the airflow over the loveseat were nearly exact (Figures 48 and 49).

Figure 48-49 – Experiment Set “B”: West Wall - Cell #1 (left); Cell #2 (right)

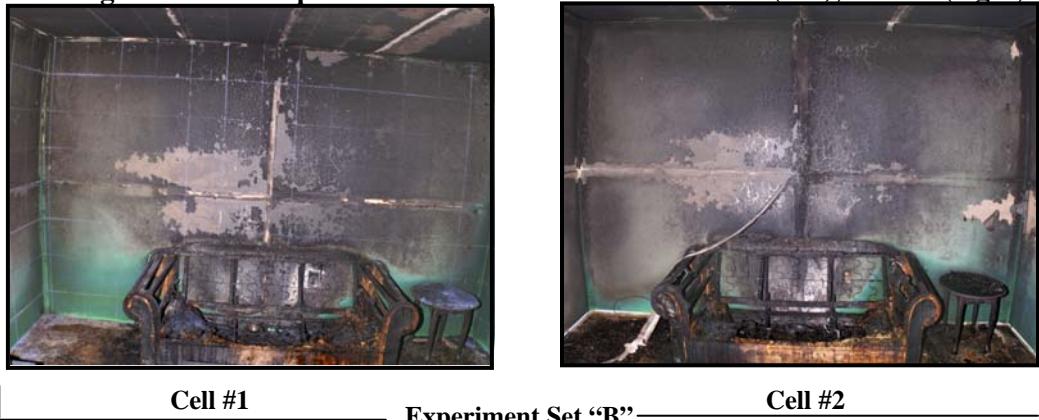
Located on the east wall above the couch, a conical-shaped plume pattern existed in almost exact appearance between the two experiments (Figures 50 and 51). In fact, an almost perfect reproduction of the area of clean burn remained on each wall behind the couch.

Figure 50-51 – Experiment Set “B”: East Wall - Cell #1 (left); Cell #2 (right)

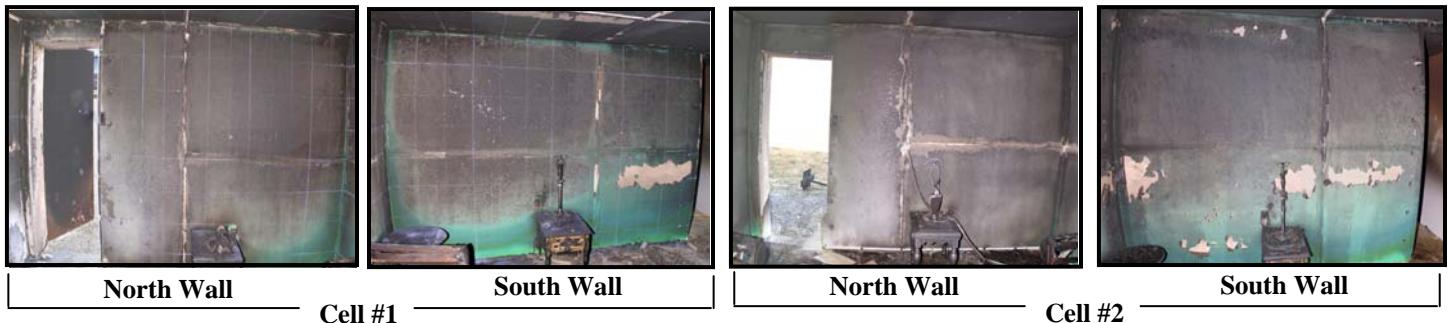
The remaining walls had similar truncated cone patterns, which originated from the plume on the couch (Figures 52-55).

Figure 52-55 – Experiment Set “B”: (left to right) Cell #1; Cell #2
